**DEPARTMENT OF TRANSPORTATION**

Contract #: 04-0120F4Cty: SF/ALA Rte: 80 PM: 13.2/13.9File #: 69.28**WELDING INSPECTION REPORT****Resident Engineer:**Siegenthaler, Peter**Address:** 333 Burma Road**City:** Oakland, CA 94607**Report No:** WIR-018808**Date Inspected:** 18-Dec-2010**Project Name:** SAS Superstructure**OSM Arrival Time:** 700**Prime Contractor:** American Bridge/Fluor Enterprises, a JV**OSM Departure Time:** 1900**Contractor:** Zhenhua Port Machinery Company, Ltd (ZPMC), Changxing Island **Location:** Shanghai, China**CWI Name:** Li Yang**CWI Present:** Yes No**Inspected CWI report:** Yes No N/A**Rod Oven in Use:** Yes No N/A**Electrode to specification:** Yes No N/A**Weld Procedures Followed:** Yes No N/A**Qualified Welders:** Yes No N/A**Verified Joint Fit-up:** Yes No N/A**Approved Drawings:** Yes No N/A**Approved WPS:** Yes No N/A**Delayed / Cancelled:** Yes No N/A**Bridge No:** 34-0006**Component:** OBG Segment**Summary of Items Observed:**

**OBG # TRIAL ASSEMBLY YARD (CB16)**

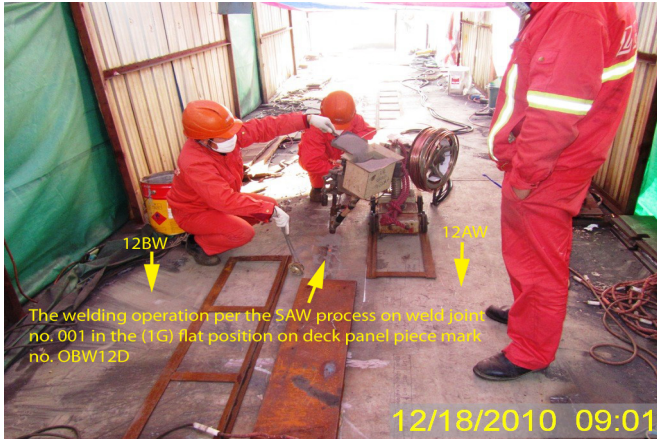
For additional information please reference the pictures below:
